**SWIMMING RIVER
RESERVOIR
NJ 00082**

**PHASE 1 INSPECTION REPORT
NATIONAL DAM SAFETY PROGRAM**

SWIMMING RIVER RESERVOIR DAM (NJ00082)

PHASE I REPORT
NATIONAL DAM INSPECTION PROGRAM

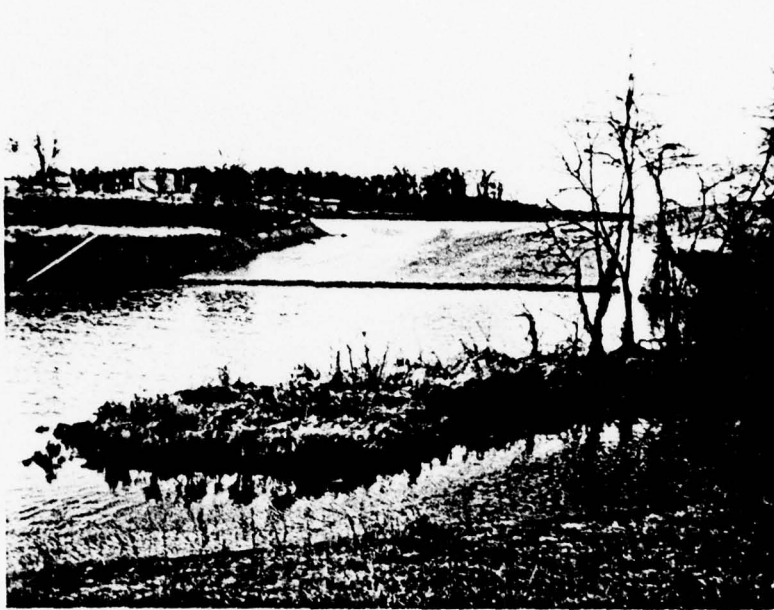
Downstream view of spillway

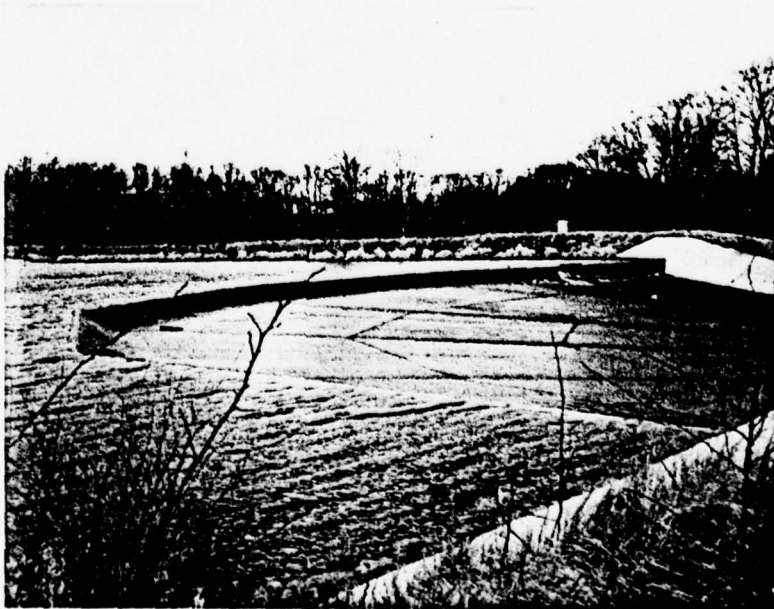
View of spillway from right embankment

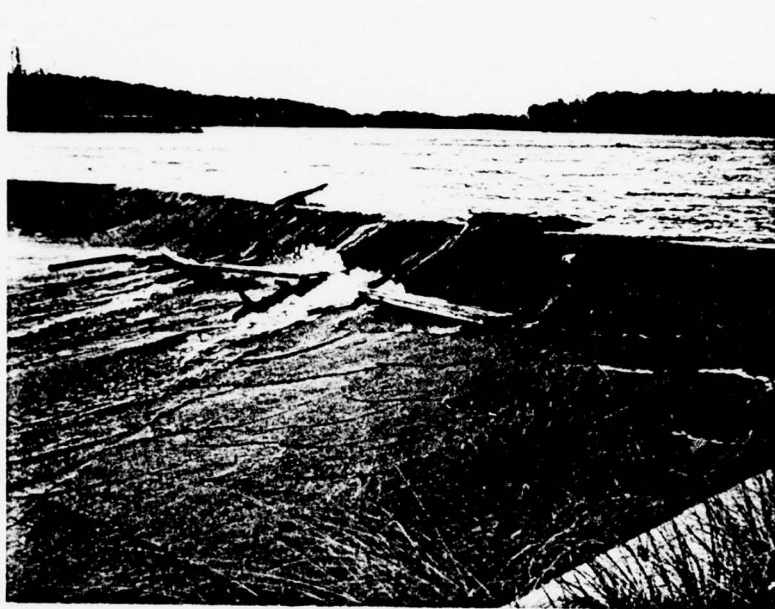
View of debris on spillway

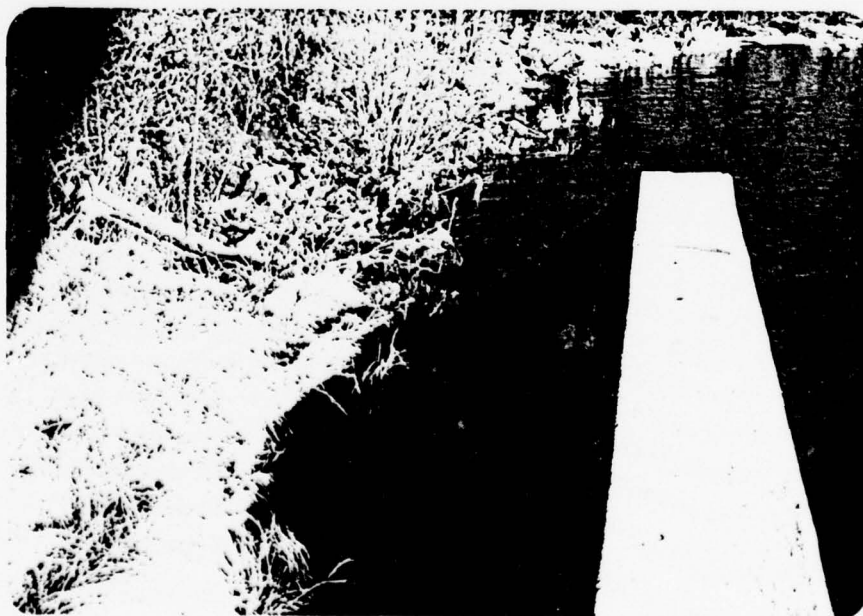
was observed here and extended about 5 feet up the slopes, and the area south of the pond beyond the toe of fill were soft and wet. Water flowing down the natural ground slopes east of the high embankment were traced to the outlet pipe from the gaging station. However, about 20 feet east, additional wet areas were observed which do not appear to be attributable to the gaging station outlet. All drains appeared to be running clear. The remainder of the dam is in a satisfactory condition except for some erosion observed behind the wingwalls of the main spillway.

View of erosion behind left wingwall

- a. Refill eroded areas behind the waterway wingwalls.
- b. Backfill and replant the minor erosion pockets at the back slopes on the northerly embankment dike.
- c. Investigate the feasibility of supplying a different type of ground cover which would take hold better on the steep dry slopes, and implement accordingly.

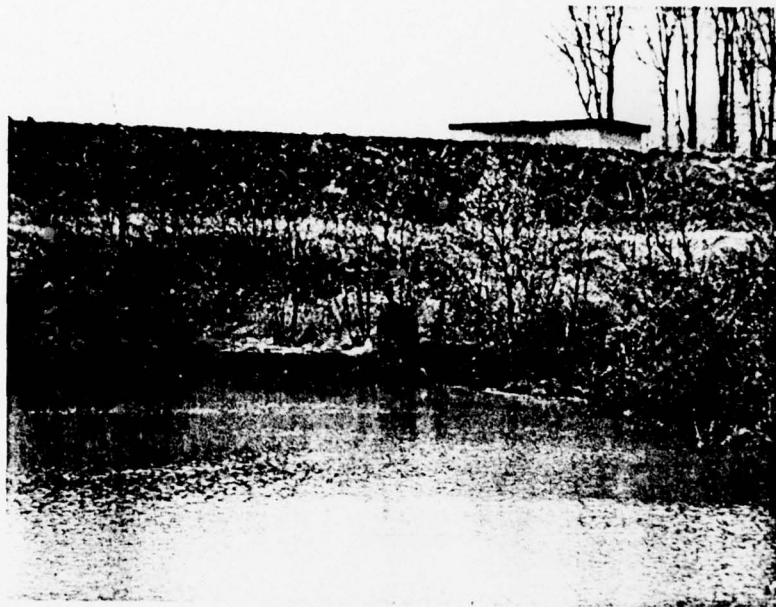
View of original downstream channel

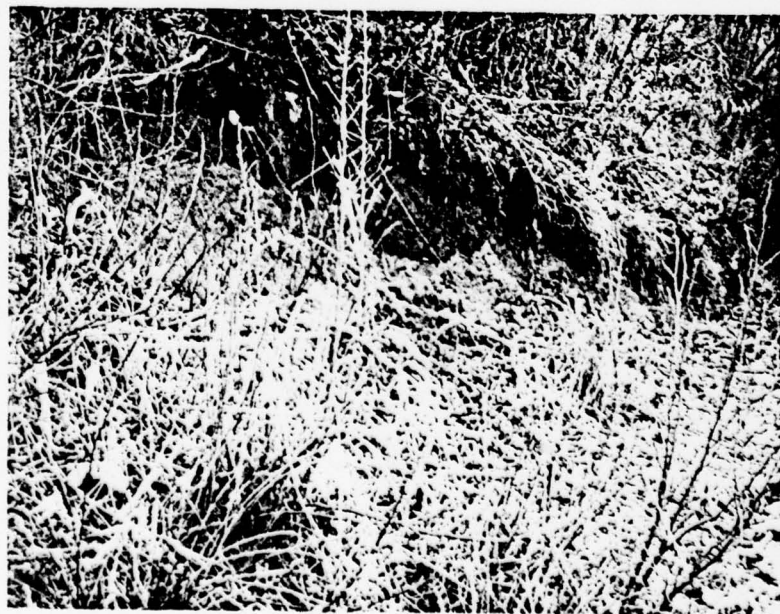
VISUAL EXAMINATION OF	OBSERVATIONS	REMARKS OR RECOMMENDATIONS
SURFACE CRACKS	None observed	
UNUSUAL MOVEMENT OR CRACKING AT OR BEYOND THE TOE	None observed	
SLOUGHING OR EROSION OF EMBANKMENT AND ADJUTENT SLOPES	Slight slope erosion localized at wall of old channel. It is an area of approximately 4' x 6' and is located near seepage area.	
VERTICAL AND HORIZONTAL ALIGNMENT OF THE CREST	Satisfactory	
RIPRAP FAILURES	None observed	No riprap on downstream slope of embankment except at stilling basin (under water).

Sloughing on downstream side of left embankment at original spillway channel

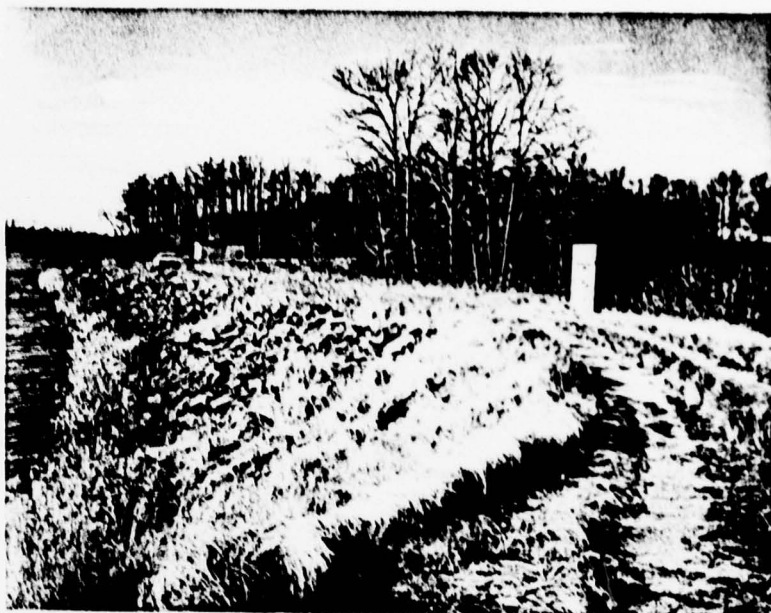
View of left embankment

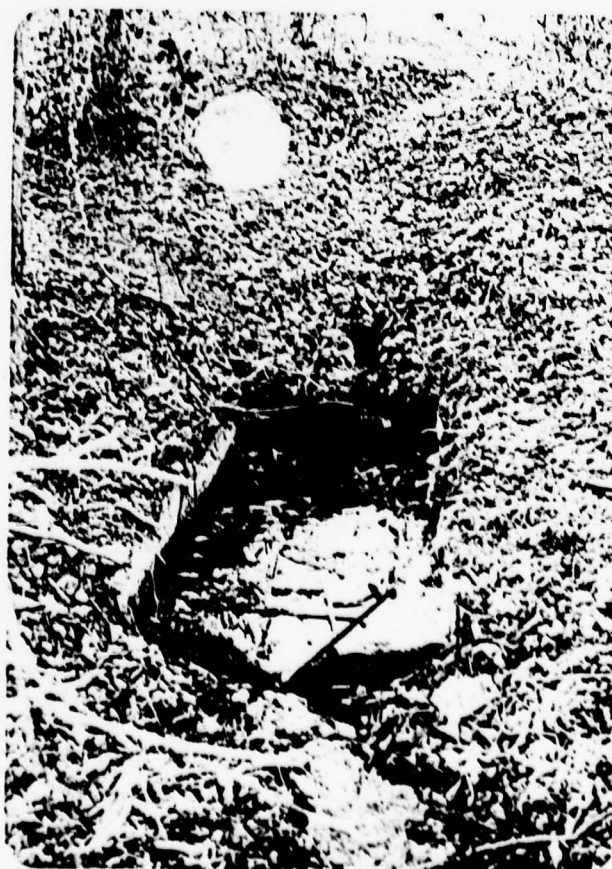
V- notched weir on downstream side of left embankment

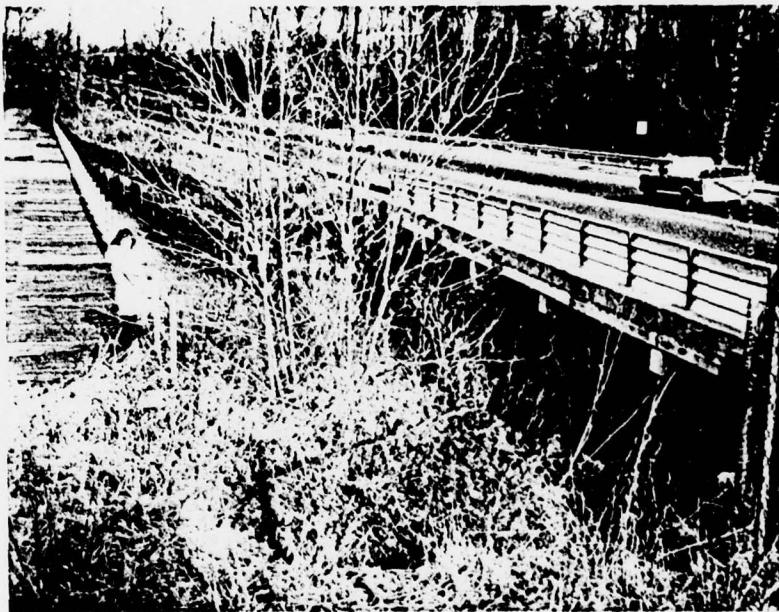
View of bridge downstream from dam
